RESTORING A FOREST WATERSHED AND ADDING WATER BACK TO THE LAND

Dan C. Abercrombie, District Conservationist
Natural Resources Conservation Service
2920 N. White Sands Blvd.
Alamogordo, NM 88310

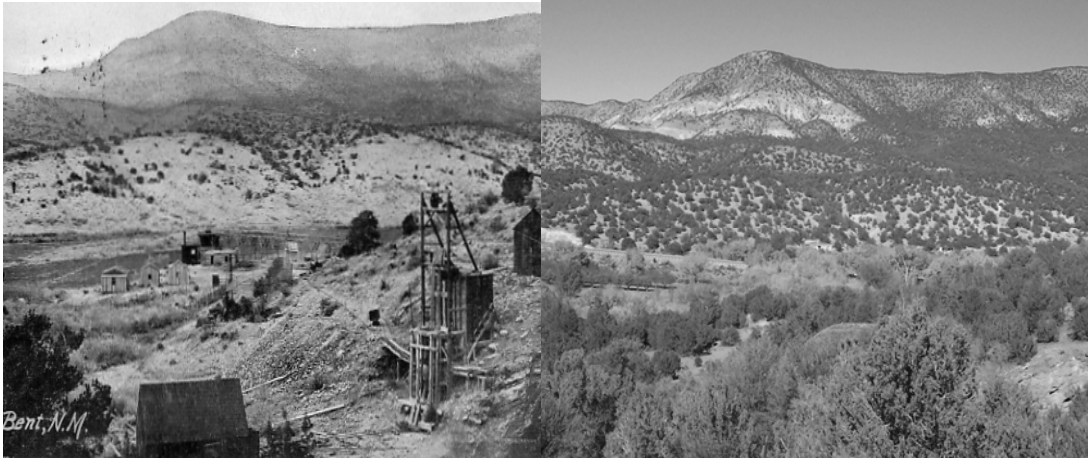
OLD BENT MINE PICTURE TAKEN LOOKING NORTH IN ABOUT 1900 AND IN LATE 2005 PORTRAYS TREE DENSITIES AT ABOUT THE SAME ELEVATION AS THE LAND THINNED BELOW TIMBERON

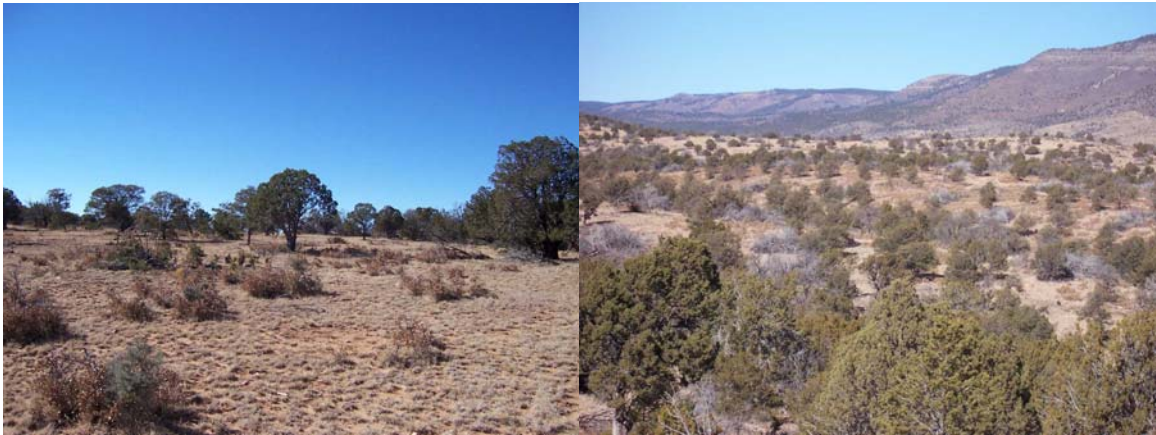
Photos depict thinning as part of a landscape with NRCS cost share program.

Three Federal grant programs were found which fit these parameters. The owner of the Elkhorn Land and Cattle Company applied for an Environmental Quality Incentive Program cost share grant through the Natural Resources Conservation Service to thin trees on his private and State land. Elkhorn restored about 1800 acres of rangeland to a more natural tree density.

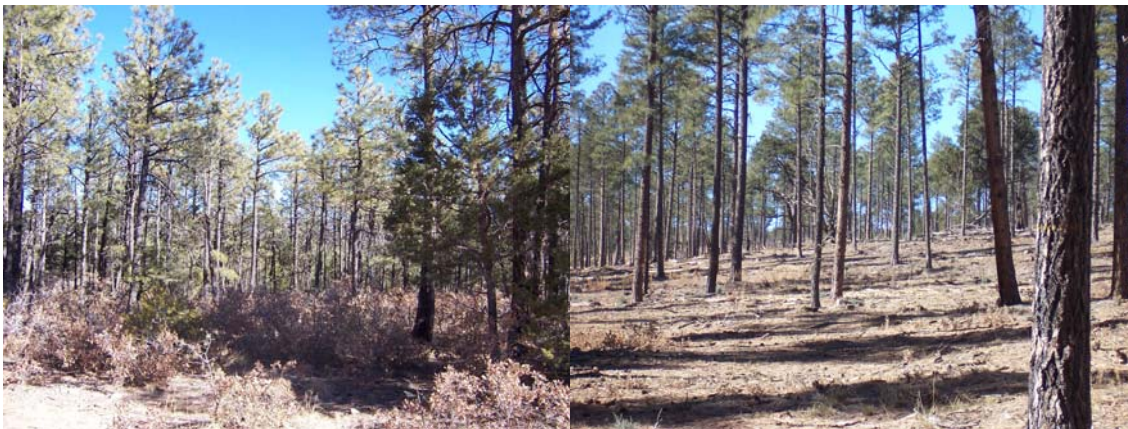
These photos depict the west side of Timberon before Ponderosa Pine is thinned and after thinning with the CFRP grant.

In 2001, the Otero SWCD successfully applied for a Collaborative Forest Restoration Program grant through the Community Forest Restoration Act of 2000. Three locations in the watershed were thinned. At Sunspot, 8 acres on the western slope below the National Solar Observatory were thinned. The Circle Cross Ranch thinned over 40 acres along the western boundary of Timberon. The Southern Cross Ranch thinned 337 acres south of Timberon.

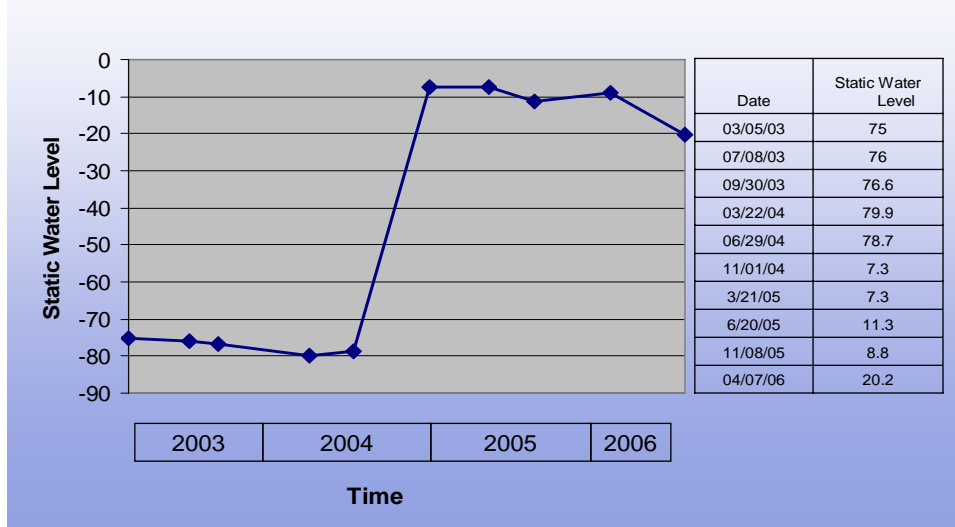
Static Water Levels Southern Cross Well

The graph portrays a dramatic rise in the water table at the lower well being monitored. This well is located in an east-west syncline or downfold in the San Andreas Limestone formation.

The Otero Soil and Water Conservation District began monitoring static water levels in five wells in the watershed about three years ago. Following the treatment and decent summer precipitation, water rose about 100 feet in a well below the treated area. The static water level in this well is now about 15 feet.

During the summer of 2004, the static water level in the southernmost well being monitored rose 70 feet.
