# Classification of the Aesthetic Value of Urban Rivers

## **Classification of the Aesthetic Value of Urban Rivers**

### **1. INTRODUCTION**

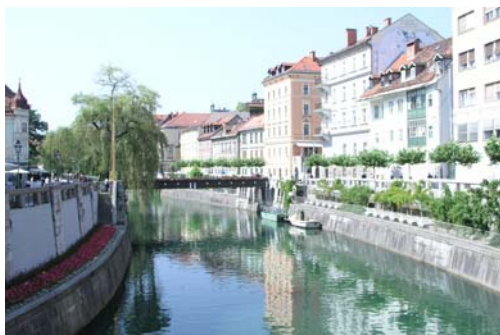
Figure 1: The Ljubljana River through the city center

The Ljubljana River study area includes a large part of the old city centre of Ljubljana with a high density of buildings. Numerous spatial activities and uses connected with the Ljubljana River have been developed in the areas around the river. The river has been used as an important transport line, port, entertainment area, market place, and also as a conduit for sewer and refuse. To reduce the flood risk, a diversion channel was excavated in the period from 1772 to 1780 between the Castle hill and the hill of Golovec according to the plan of a Jesuit, Gabriel Gruber. In the 19<sup>th</sup> century, the Ljubljana River and surrounding areas provided a continuously attractive social space. Later, the regulation and deepening of the Ljubljana River channel was carried out in the reach of the river through the Ljubljana city centre. The image of the river changed drastically between 1913 and 1918, when banks on the river section through the city were heavily reinforced with high concrete walls. The plan for regulation was developed by engineer Alfred Keller. The natural Ljubljana River channel was transformed into a ditch, which alienated the river body from the city life. The monotony of the river channel regulation was changed by architect Jože Plečnik in the 1920's and 1930's (Figures 1–2).

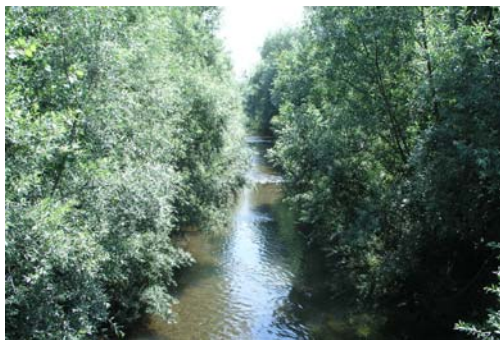
Figure 3: The Mali Graben River

In the past, the course of the Mali Graben was situated apart from the urban area of the city of Ljubljana. Due to the fast development of the city that eventually grew into an important cultural, political and economic regional centre, the Mali Graben became the boundary between the managed urban space and the green urban space on the periphery. The densely built-up areas are located mostly to the north of the river, directed towards the city centre. During the last two decades, the urbanization spread to the right bank of the Mali Graben. As anticipated, these areas of Ljubljana will face further building expansion (Figures 3–4).

The degree of the disturbance of natural dynamic processes in the Ljubljanica River corridor is high due to the high building density in the city centre (Figure 3). The river channel was deepened several times, the banks are reinforced with almost vertical concrete walls. On short subsections, the banks are grassed above the concrete walls. In the study reach, some individual trees and lines of trees are present on the top of the banks. Inside the narrow city centre, the riparian vegetation is completely absent. The local sinuosity of the river was diminished with the regulation works. Along the entire study reach, the cross section is of trapezoidal shape with unchanged slope and bank arrangements. The hydro-morphological elements of the natural river channels (runs, pools, riffles, weirs, asymmetric cross sections) were removed from the stream channel during the regulation works in the 19<sup>th</sup> century. The average performance of the fundamental viewpoint “River Morphology” for the Ljubljanica River is 20.8 %.

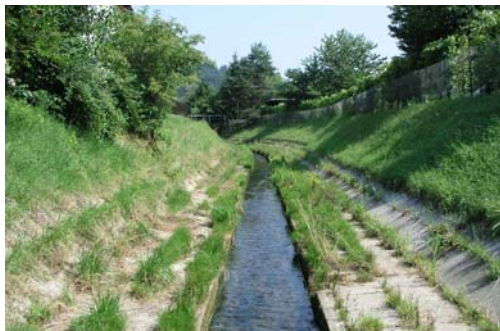
**Figure 5: The Glinscica Stream**

The Glinscica Stream has its source under the northeastern slopes of Toško čelo and at Podutik passes into the plain area of the Ljubljana Plain. The topography of the basin is comprised of a hilly area to the east and west and a plain area that spreads out in the southern part. The relief of the Glinscica drainage basin is versatile, comprising hilly headwater areas as well as plains. The precipitation watershed area of the Glinscica comprises 17.4 km<sup>2</sup>. The position of the runoff within the urban area is determined by the removal of rainfall water by way of a sewage system, thus the orographic barrier fails to coincide with the Glinscica drainage. The total drainage area of the Glinscica up to its outlet into the Gradaščica is somewhat bigger and comprises 19.3 km<sup>2</sup> of the catchment area. There are an estimated 38 % of urban areas, that is 6.6 km<sup>2</sup> (Figures 5–6).
