# Prius High Voltage Battery Diagnosis and Upgrade

Prius!  
Uncloaking High Voltage  
Battery Mysteries.  
Corrosion Happens!  
by Tim Janello

# 2003 Prius HV Battery Issue

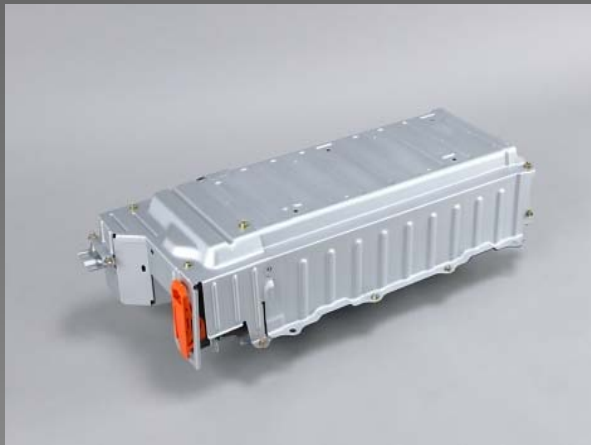
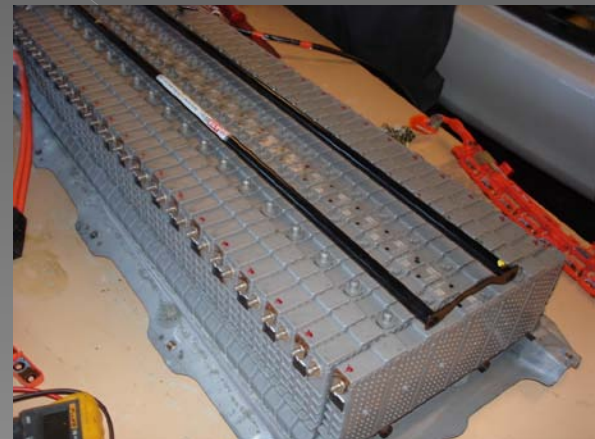
- ◉ 150K miles
- ◉ MIL On
- ◉ Tested HV Battery
- ◉ #10 Block Showed Bad
- ◉ Decided to Upgrade to Gen II Cells
- ◉ Neglected Maintenance

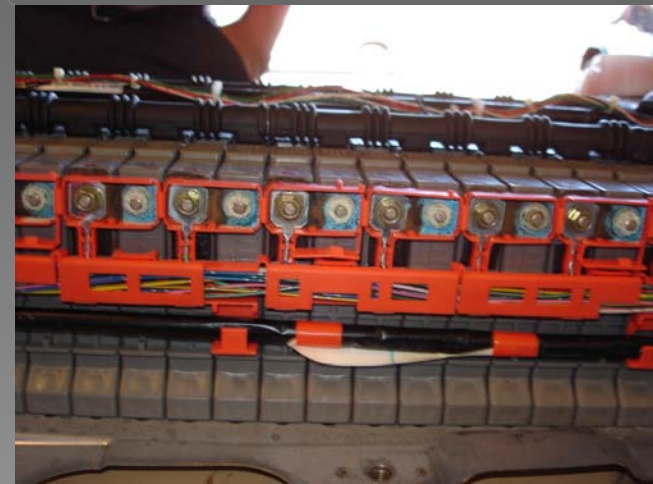
# Sensing Connections

- ECU Senses Each Block
- Uses Bus Bar
- Small Wires
- Connected at Each POS Block Terminal
- 1 Connected to NEG Bus Bar

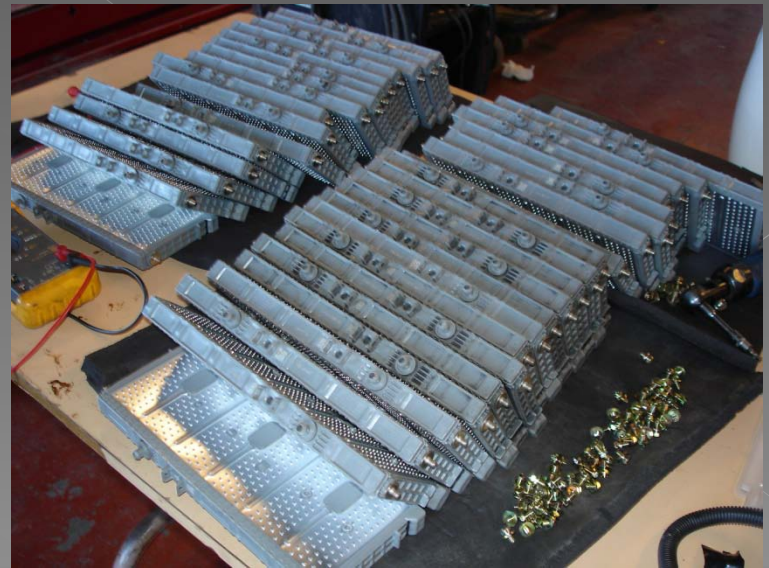
# Upgrading HV Battery

- 28 Cells
- 201 Volts Static
- About .75" Longer
- High Capacity

- ◉ 38 Gen II Cells
- ◉ Newer in Age
- ◉ Improved Design
- ◉ Around \$800

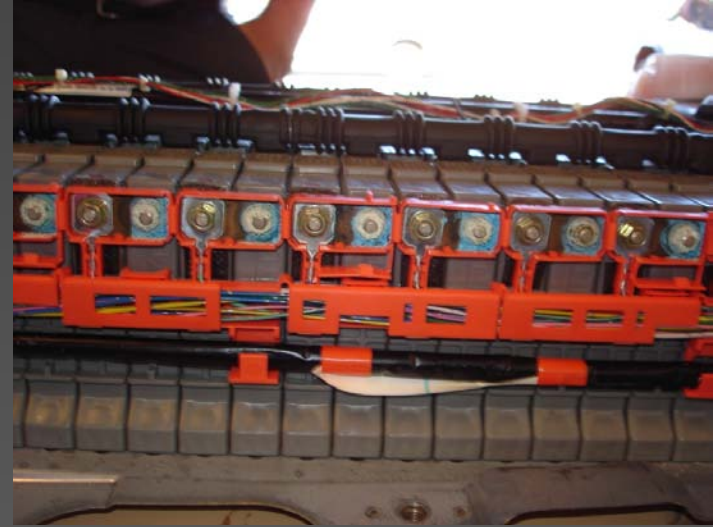
# Voltage Issue

- Both Bus Bars Removed
- Only Cell Voltage Left (7.2V)
- Remove POS Bus Bars
- Check Sensing Connections
- See a Problem?

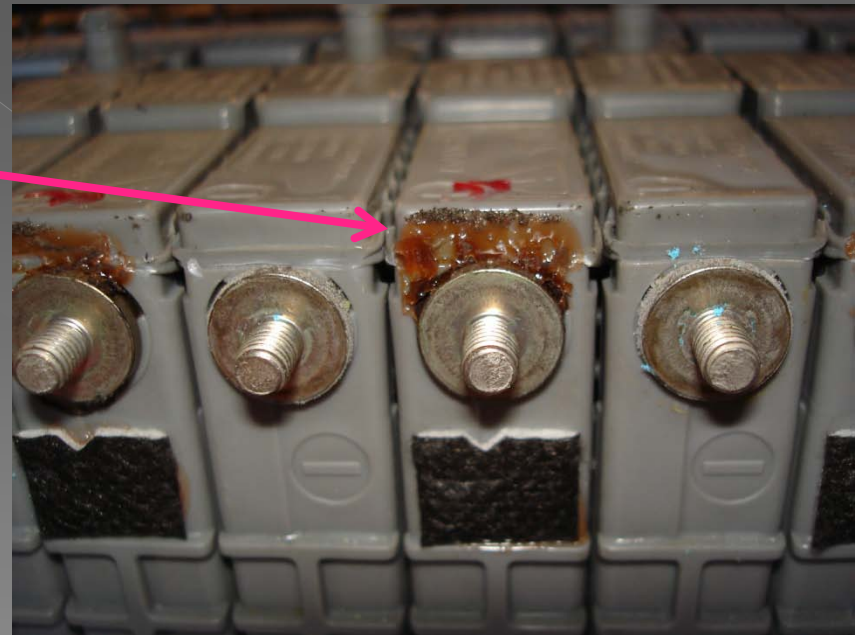
# Original Cells

- First Thought "Acid Leaking?"
- After Bus Bar was Removed
- Cells Were Clean
- Epoxy Shown
- Factory Seal
- TSB Kit
- All Tested 7.2V
- Moisture & Copper?

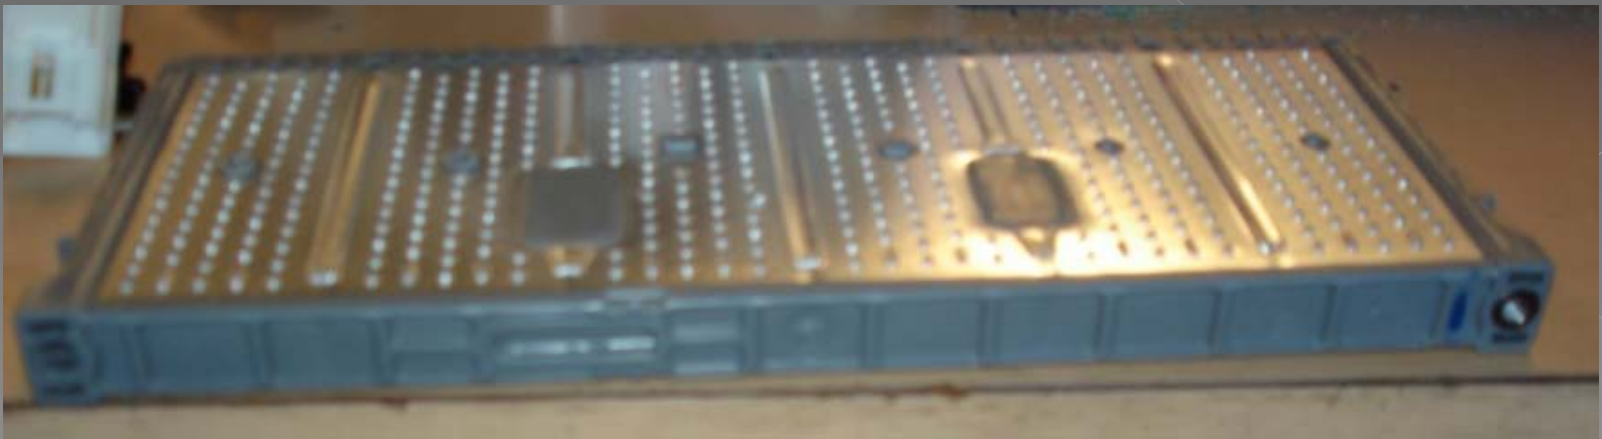
# Installing Upgrade Cells

- New Cells Are Longer
- Won't Interchange
- Only 1 Bolt At POS End
- Reassembled Battery

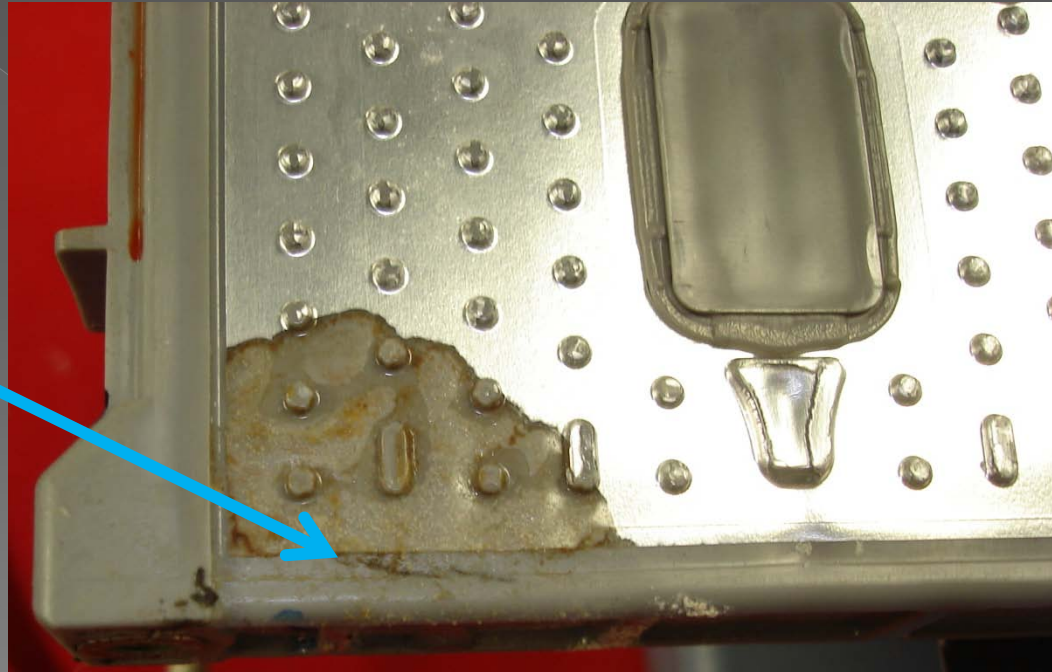
# Cracked Cell

- ◉ Vehicle Drove 5 Miles
- ◉ MIL ON
- ◉ DTC 3009 (HV Leakage)
- ◉ Means HV on Vehicle Chassis
- ◉ Removed HV Battery Assembly
- ◉ Cells were Still HOT

- ◉ What Was Found?
- ◉ Block in Middle
- ◉ Cracked
- ◉ Acid Leaking
- ◉ HV on Housing

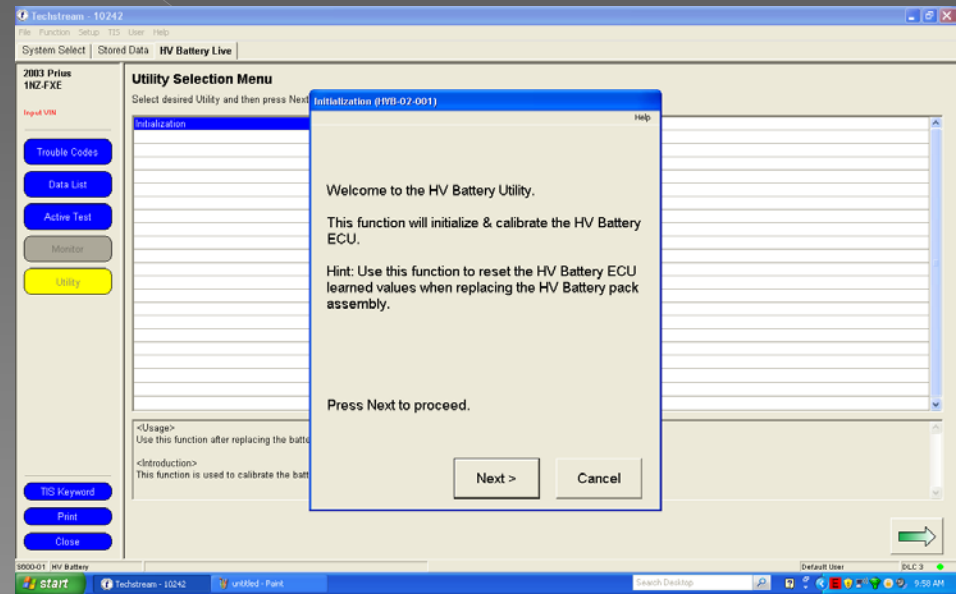
# Initializing

- Tech did not Initialize the HV ECU
- Overcharging
- ECU Did Not Relearn Quick Enough?
- HV Battery ECU Utilities

- Cannot Interchange Cells
- Reinstalled Original Cells
- Initialized System
- Performed Stall Test
- Graphed Swing V
- All Cells Within .3V
- ICE Did Not Restart as Often
- Performed in October, 2011
- Not Problems
