**Conference** Proceedings

# Restoration of the Rio Grande/Rio Bravo in the Juarez Valley: An analysis

#### Restoration of the Rio Grande/Rio Bravo in the Juarez Valley: An analysis

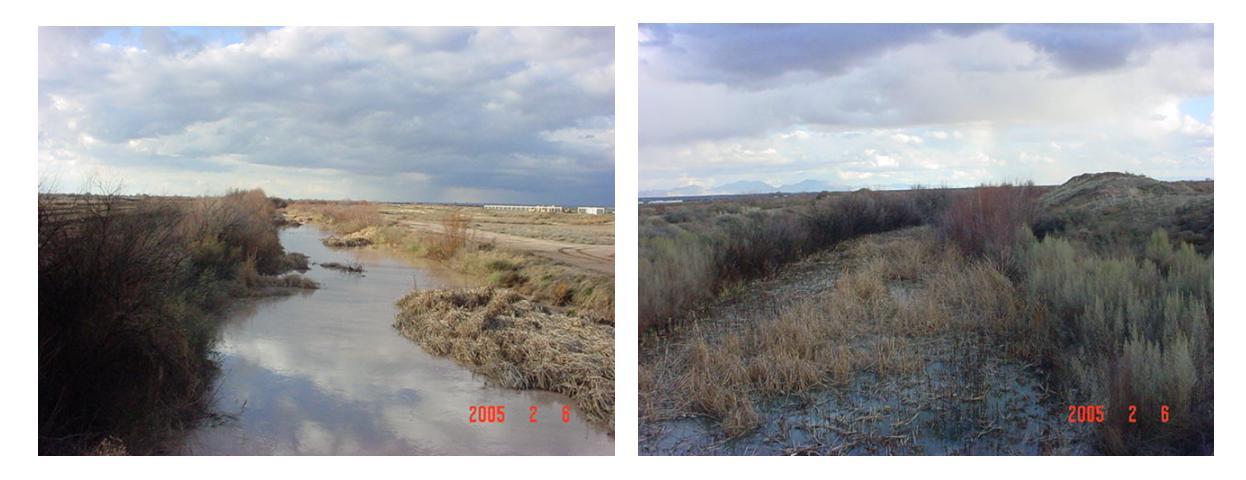
Figure 1 U.S. Drain at the river flow

Figure 2 Mexican Drain

The U.S.-Mexico water treaty (1906) supplied a fix and small portion of the river's annual flow to Mexico. The treaty was the result of a controversy between these two countries and, from the Mexican perspective, the convention was unfavorable to Mexico (Bustamante, 1999). The Environmental Cooperation Commission considers that Mexico resigned to any and all the claims to the Rio Grande/Rio Bravo water between the beginning of the present Mexican Canal (Acequia Madre) and Fort Quitman (CCA, 2001). The water allocation to México is 74 million m<sup>3</sup>/year (60,000 acre-feet/year) that were given by courtesy by the U.S. In case of a drought, the U.S. is not compelled to deliver any water quantity. This water volume is insufficient for cultivation field in the Juarez Valley. The irrigation infrastructure both side of the border is the cause that in the region of study the water runoff comes from irrigation return flows Figure 1 and 2.
